Navajo Abandoned Uranium Mine

Site Screen Report

Mine Name: Mitten No. 2
Mine ID: 704

April 2012

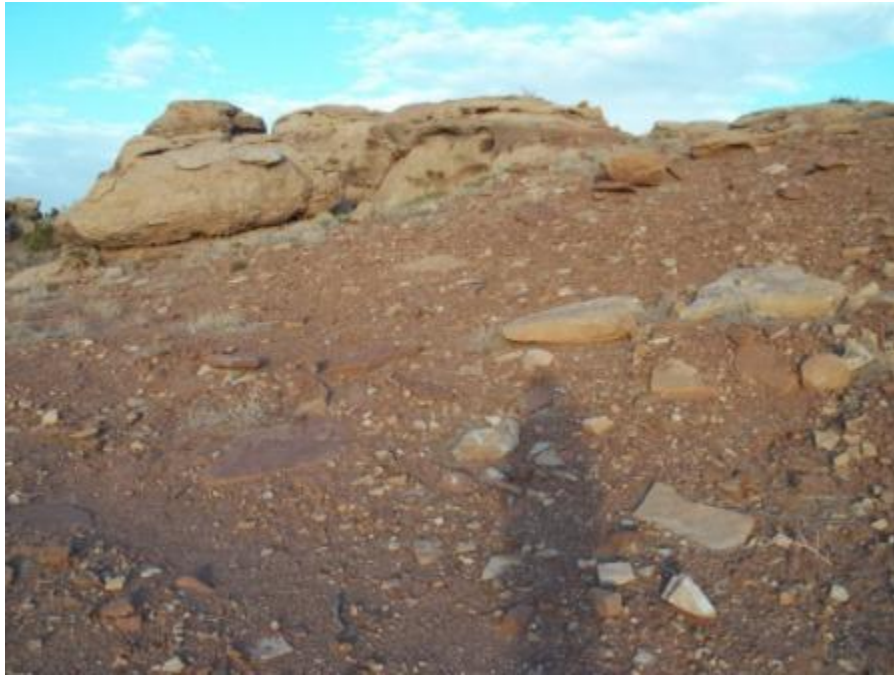
Photo 1

Mine Site #704

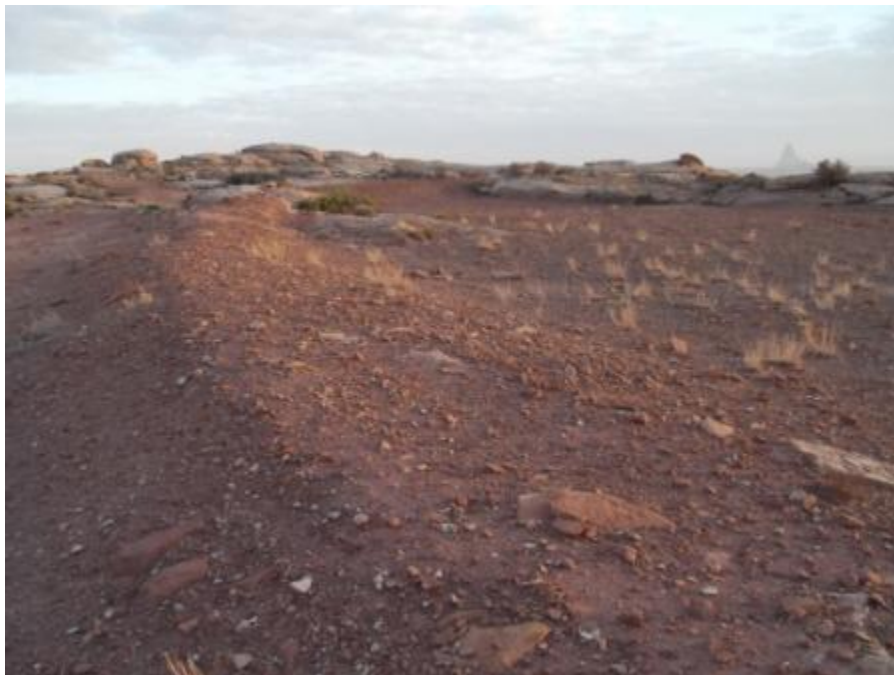
Photo 2

Capped and bermed area shared with site #247; dump area 50 ft north of the site

Mine Site #704 – Berm area
